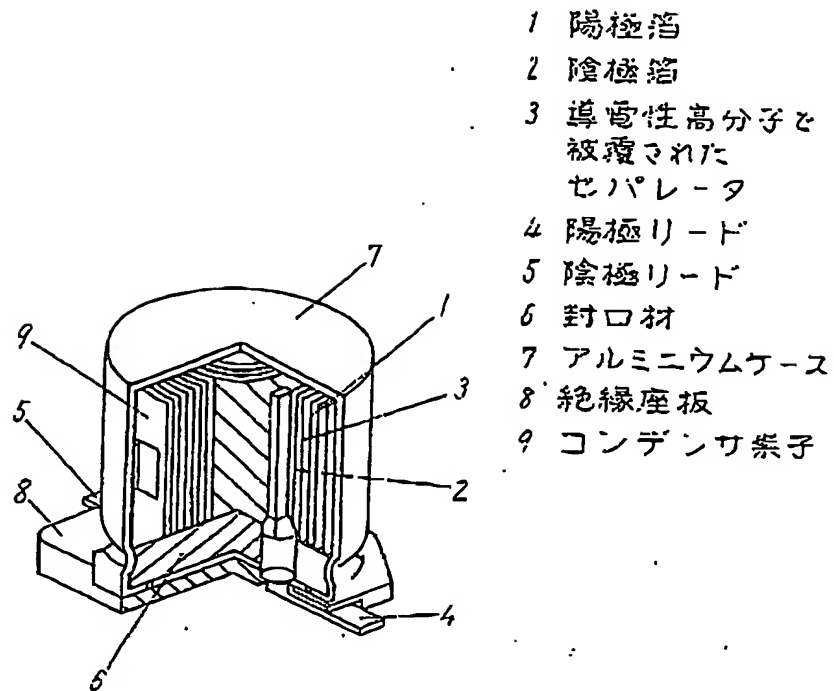
Fig. 1

- 1 Anode Foil
- 2 Cathode Foil
- 3 Separator Coated with Electroconductive Polymer
- 4 Anode Lead
- 5 Cathode Lead
- 6 Sealant Member
- 7 Aluminium Case
- 8 Insulation Seat
- 9 Capacitor Device
